RADC-TR-76-208  
Interim Technical Report  
July 1976

**INVESTIGATION OF DEFECTS AND IMPURITIES  
IN SILICON-ON-SAPPHIRE**

**Rockwell International Corporation**

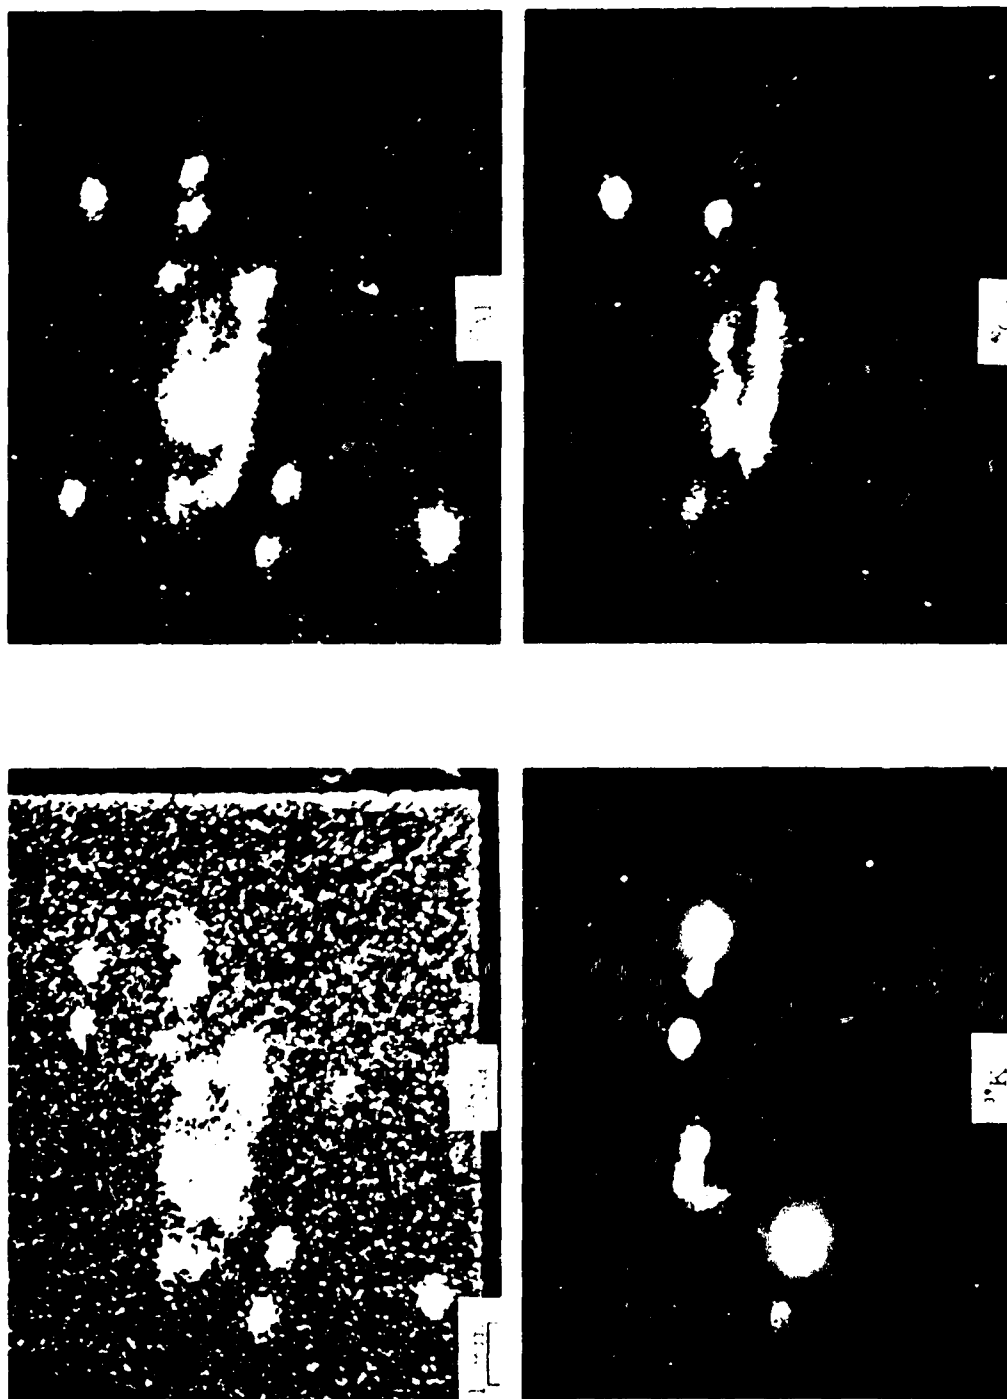
Figure 8. IMMA Elemental Surface Map of Union Carbide SOS Material

Silicon films deposited by Union Carbide and Hewlett Packard were analyzed using IMMA. Almost without exception, the contaminants found in the epitaxial silicon films were either on the surface or were distributed throughout the epitaxially deposited silicon layers. IMMA surface mapping analysis indicates that these contaminants consist primarily of residual polishing components and sapphire debris remaining in scratch regions on the surface of the sapphire substrate. Figure 8 shows an IMMA surface map of a sample of Union Carbide epitaxial silicon on Union Carbide sapphire. The individual elemental surface maps were made on the basis of overall impurity levels revealed by an initial elemental scan of the area of interest. The area mapped in Figure 8 was

subsequently examined with a scanning electron microscope which revealed an apparent defect in the sapphire substrate. An SEM photomicrograph of the area is shown in Figure 9(a) and 9(b). The photograph in Figure 9(a) shows a shadowy line, marked by arrows on either side of the photograph, which appears to be a defect in the sapphire substrate. The light colored irregularity in the center of Figure 9(a) corresponds very closely with the surface maps of Figure 8.

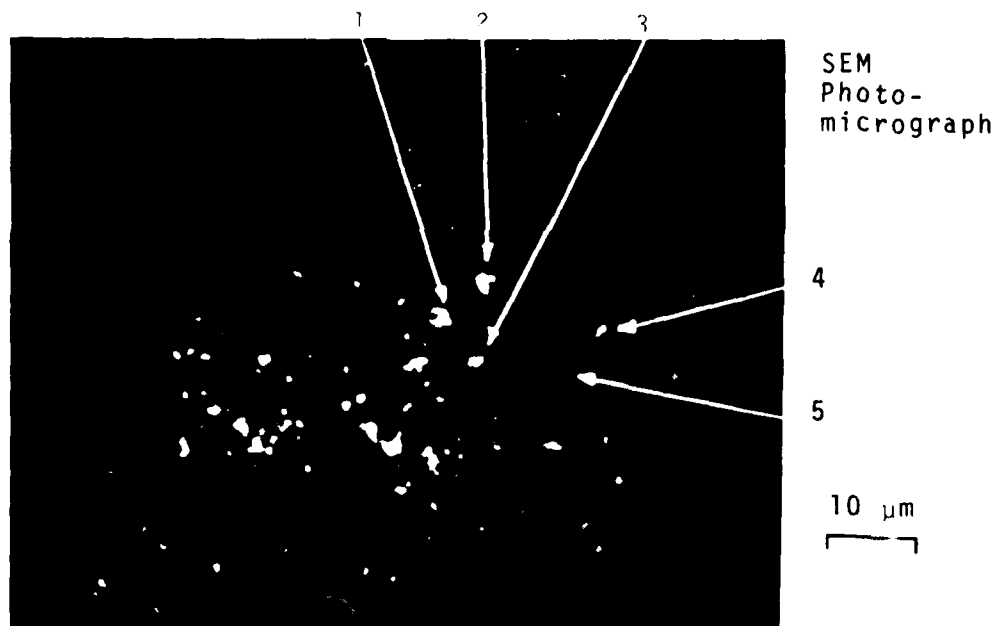
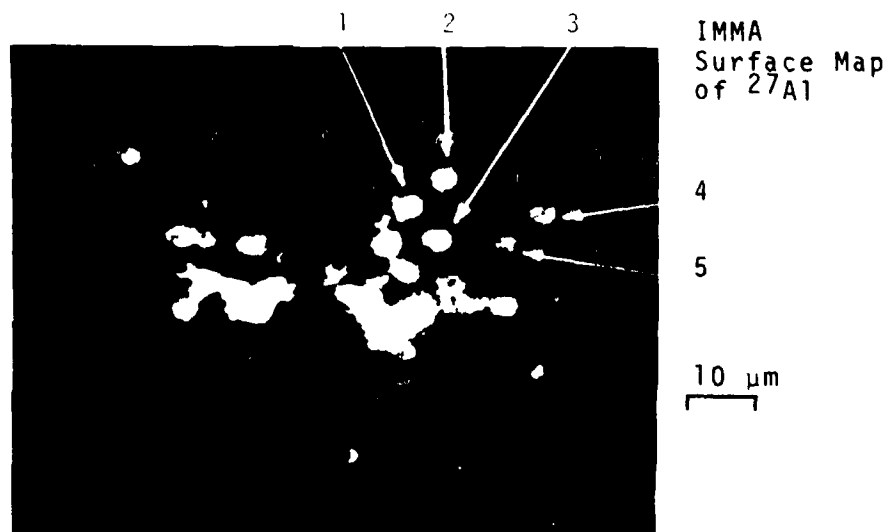
Figure 10. Comparison of IMMA and SEM Observations  
of Epitaxial Silicon-on-Sapphire

As noted earlier in this report, it was not possible to obtain the required films from the in-house source. Samples from one run, however, were saved as examples of "poorer" quality SOS films, resulting from inadequate process control. Figures 10 and 11 show IMMA surface maps and SEM photomicrographs of typical epitaxial silicon films that were obtained. In both figures, the main contaminant is aluminum appearing as particulate matter introduced during sapphire preparation.

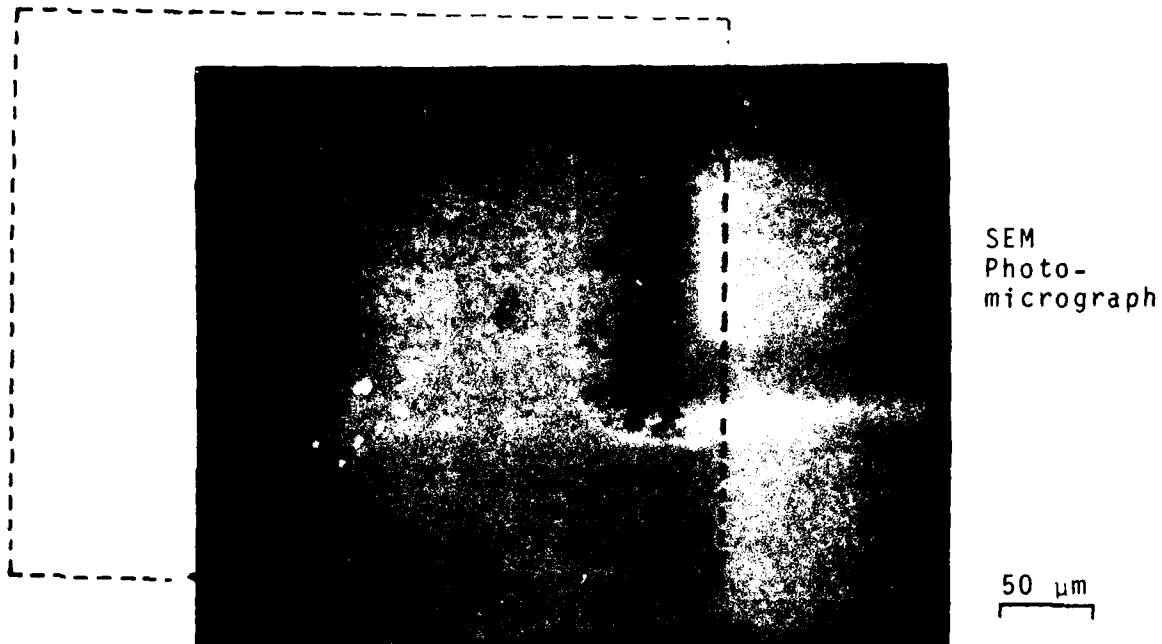
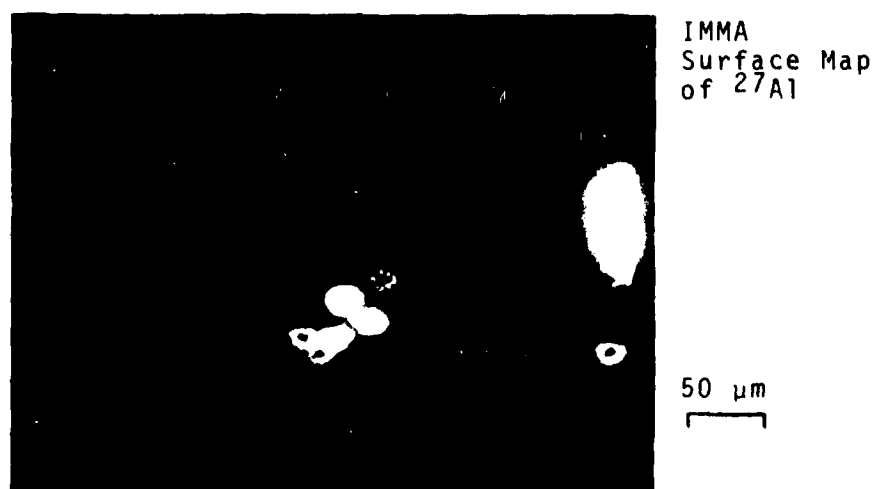
Figure 11. Comparison of IMMA and SEM Observations of Epitaxial Silicon-on-Sapphire

Epitaxial silicon films were deposited by Hewlett Packard on sapphire wafers from each of the three vendors, and these wafers were used as the second-source of epitaxial films. The silicon films furnished by Hewlett Packard were comparable in surface quality to those received from Union Carbide. An IMMA elemental scan and surface map of a Hewlett Packard silicon film grown on Crystal Systems sapphire, polished by Insaco, showed a high degree of contamination. Subsequent optical examination at 560X revealed a very fine scratch or defect running through the area of the IMMA raster. A surface map of an adjacent area on the same specimen showed no particulate or localized contamination sites.

Particulate contaminants were found to be present in the epitaxial silicon films obtained from all sources. However, it should be pointed out that the examples presented in this report represent the extreme in most instances. No attempt was made to seek out sites of contamination in any of the materials analyzed, and where contaminant sites were found, it was usually possible to move to a different location on the sample and find relatively clean areas. Of the epitaxial films examined under this contract, the Union Carbide and Hewlett Packard films were of comparable quality. The in-house material was of generally poorer quality with a high degree of particulate contamination present over the entire wafer surface.

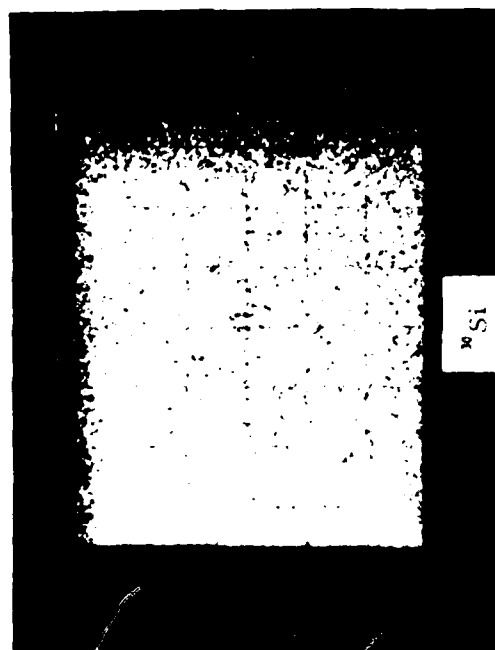
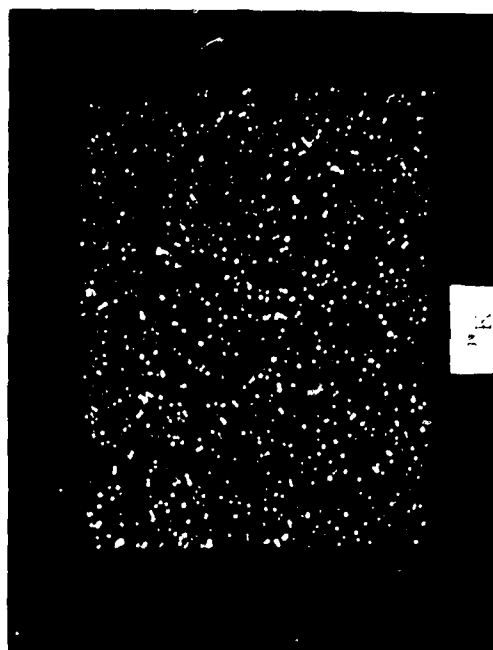
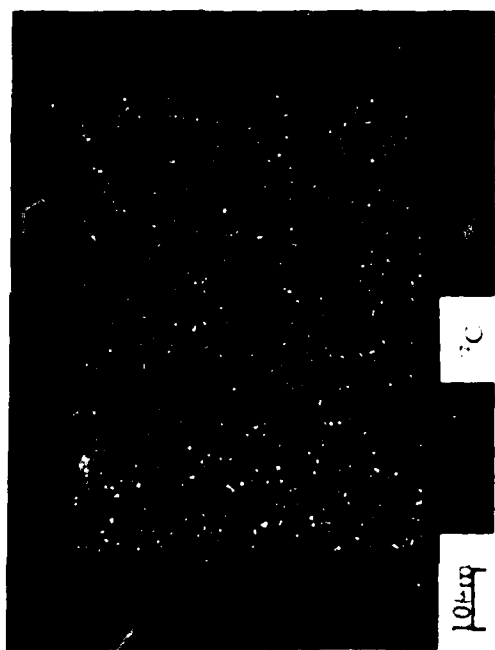
Figure 17. IMMA Surface Map of n-Channel Region of 4007 Device

IMMA examination of the circuits on Union Carbide sapphire showed uniform, low concentrations of contaminants over the entire n-channel devices. The set of surface maps shown in Figure 17 covers an area approximately 75 x 60 µm on one corner of an n-channel device. All eight channel edges were examined and found to be free of any localized sites of contamination.

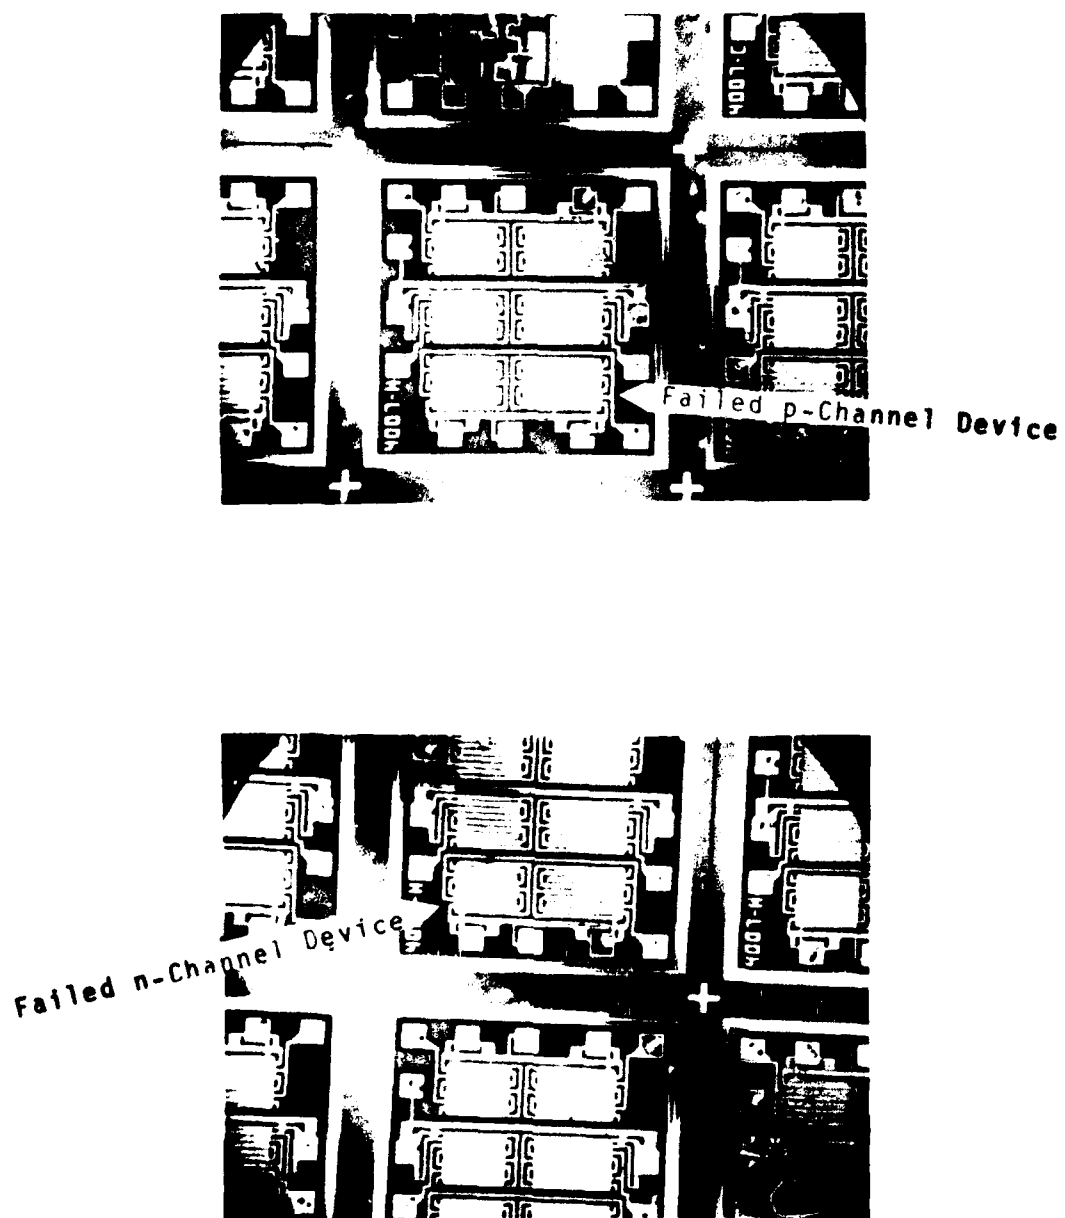
Figure 18 shows two different areas on circuits fabricated on the Crystal Systems/Insaco sapphire prior to stripping of silox and metal. The diagonal lines running through the circuits appear to be saw marks which remain after sapphire polishing. Surface map analysis of the failed devices showed that there were no differences in contamination levels in the saw marks and surrounding material. However, in the p-channel device, the ion-beam sputtered through the silicon more rapidly over the saw marks than in the surrounding area. This result indicates that one mechanism that should be further studied to explain the excessive n-channel leakage is phenomena associated with structural irregularities in the silicon caused by the nonuniformity in the surface of the substrate. Such irregularities may enhance

Figure 18. 4007 Circuits Fabricated on Crystal Systems Sapphire, Showing SAW Marks Running Through Failed Circuits

diffusions from the source-drain regions causing increased leakage and affecting eventual device yield.

The wafer maps for leakage currents showed that all groups of material were capable of producing good CMOS/SOS circuits. The yields found on some Crystal Systems wafers, with Insaco polish showed that very high yields could be achieved on material which had earlier shown a high defect density with highly scratched surfaces; however, it appears that devices lying along, or adjacent to, deep saw cuts tended to fail more readily than those between the saw marks.

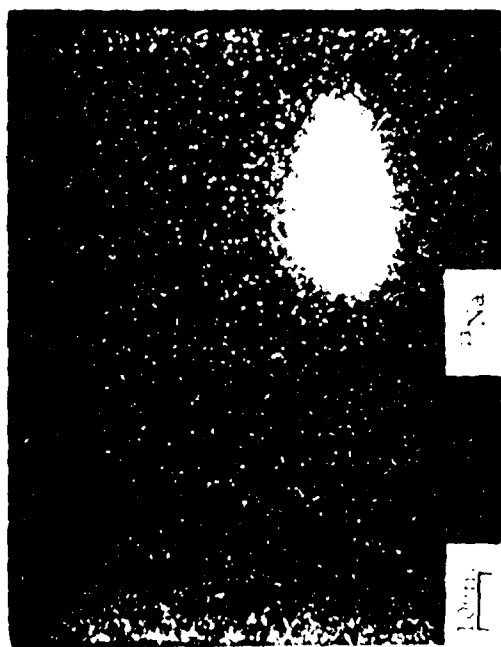
Figure 19. IMMA Surface Map of 1 mm<sup>2</sup> Test Pad on Union Carbide Sappinire with Union Carbide Epitaxial Silicon

Surface map analysis was also performed on the 1 mm square test areas, described above, representing starting and p-well implanted regions.\* These test areas were not subjected to all the processing steps used in circuit fabrication and as a result very little of the original surface was consumed. A high degree of contamination was found in these areas, much of it being localized at point-sites. Surface maps are shown in Figures 19 and 20 for the Union Carbide and Crystal Systems substrates, respectively, with Union Carbide silicon epitaxy.

The IMMA results indicate that most of the initial contamination sites, observed on the starting SOS material, were removed during the several oxidation and subsequent etching and diffusion cycles carried out during the fabrication of the circuits.

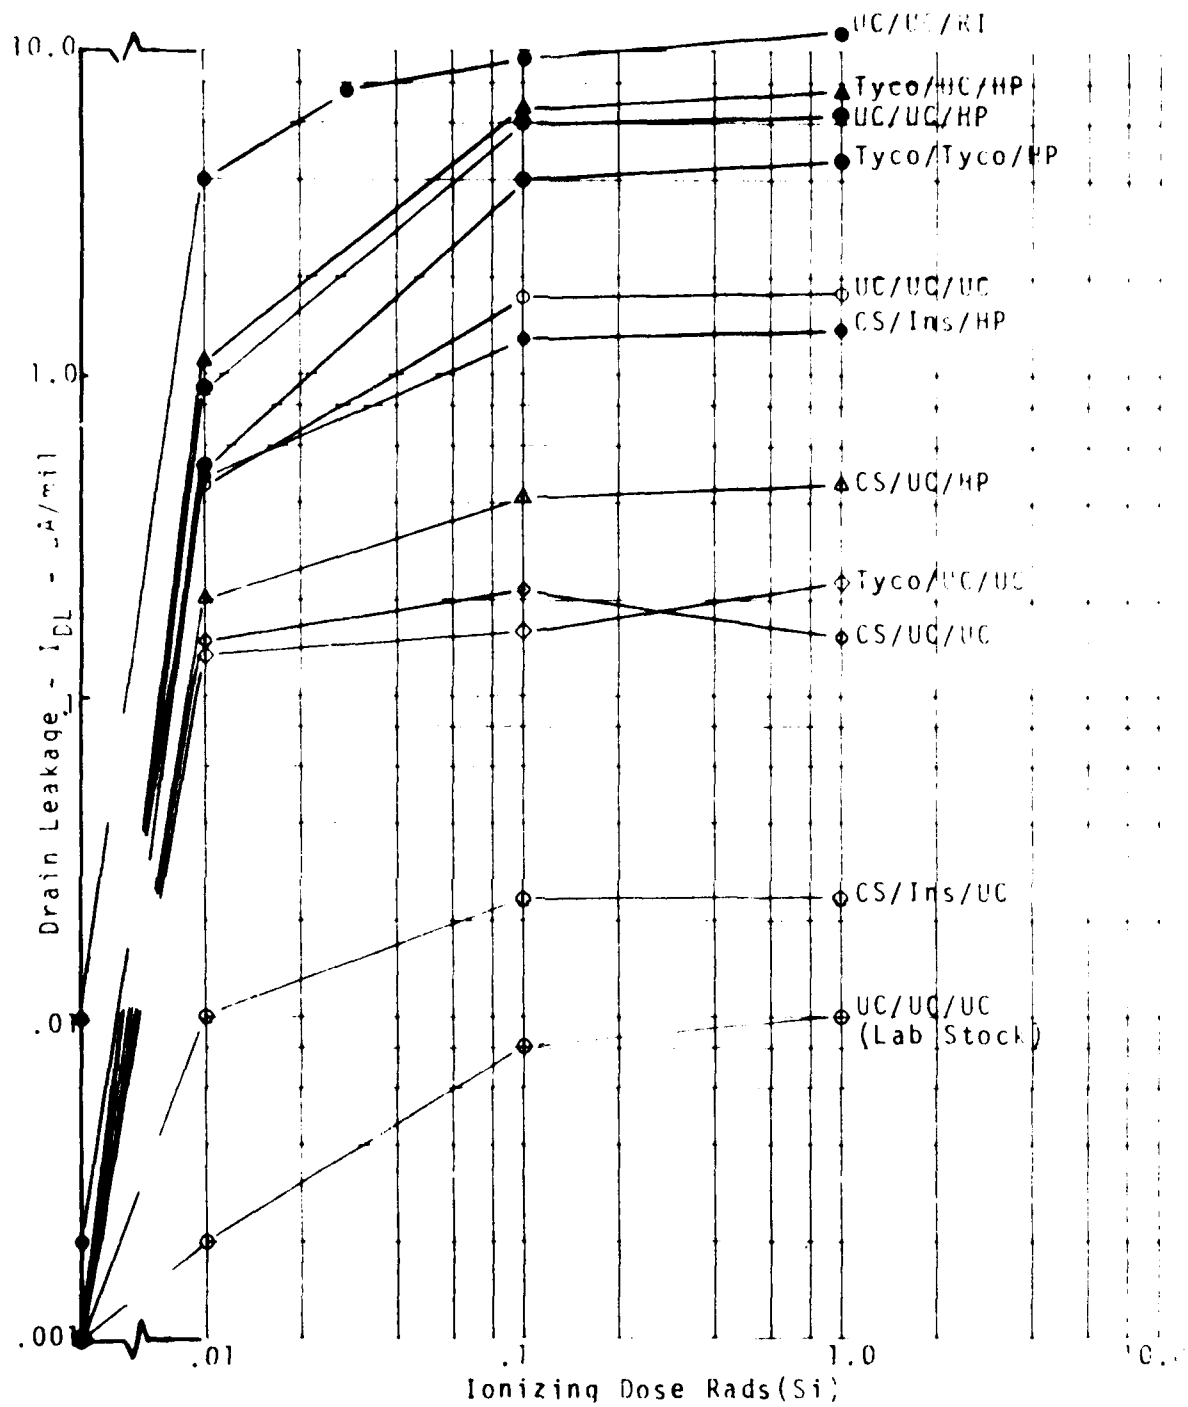
The radiation-induced drain leakage results for lots 504, 505 and 507 are shown in Figure 27. The results from lot 504 with the Union Carbide films was excellent for the Tyco, Crystal Systems, and Union Carbide (lab stock). The excellent results observed for lot 504 were confirmed by leakage data from lot 503, although these data are not shown here. The U.C. films tended to be the cleanest silicon depositions. The Rockwell films in lot 505 showed the worst response and by far had the worst silicon cleanliness. The Hewlett Packard results were intermediate--they ranged from good to poor.

Results observed here tend to show the same trends as those observed for other internally-funded material research projects. It was found that the more contaminated the silicon films, the worse the radiation-induced backchannel leakages. The cleanliness of this silicon film does not seem to affect the radiation hardness of the gate oxide, however.

Figure 27. Radiation induced drain leakage current,  $I_{DL}$ , for the condition  $V_{DV} = +10V$ ,  $V_G = V_S = 0V$  on n-channel devices fabricated on Union Carbide (UC), Lockwell International (RI), and Hewlett Packard (HP) silicon epitaxies. Each point is the average of three samples across each wafer.
